Chartered Surveyors  
Building Surveying Consultants

**77 Circular Road  
Douglas  
Isle of Man IM1 1AX**

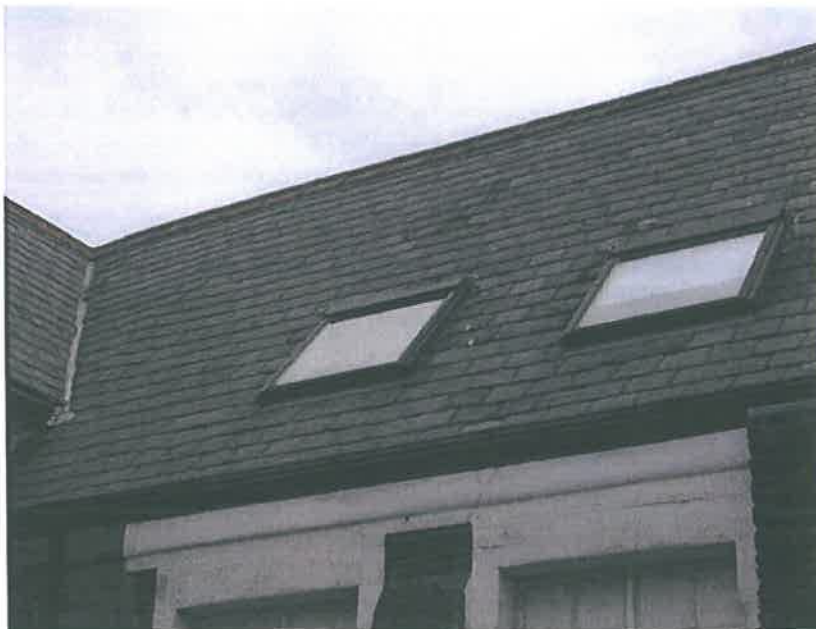
**Plate 4 – Roof, south west slope noting tangles, slate chips and slipped slates to the valley. Note crazed and cracked render to the window concrete surround and head of wall detailing.**

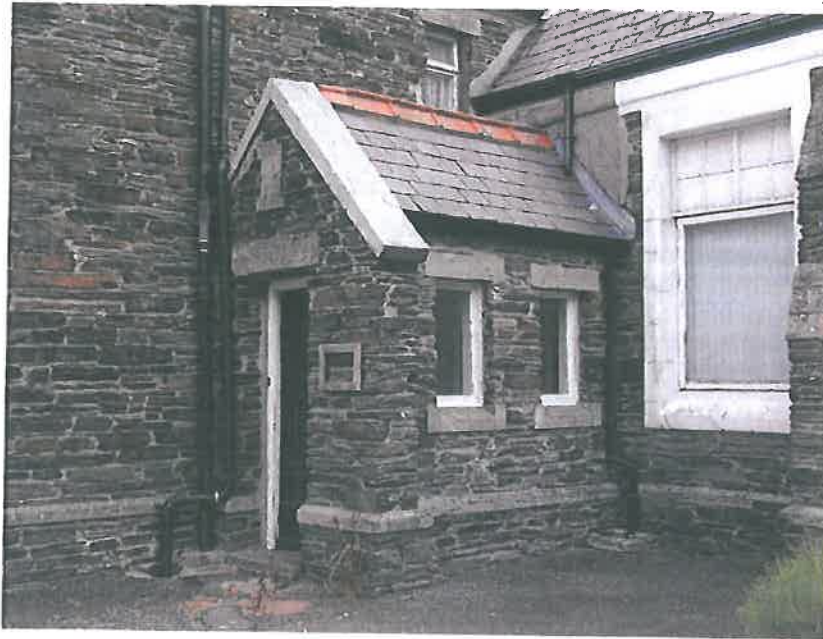
**Plate 5 – Porch (north) roof noting repaired mortar capping to verge**

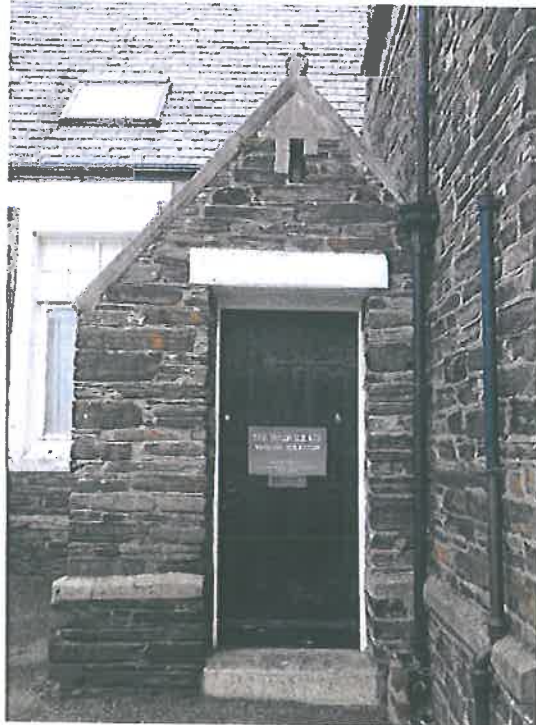
**Plate 6 – Porch (south), general view**

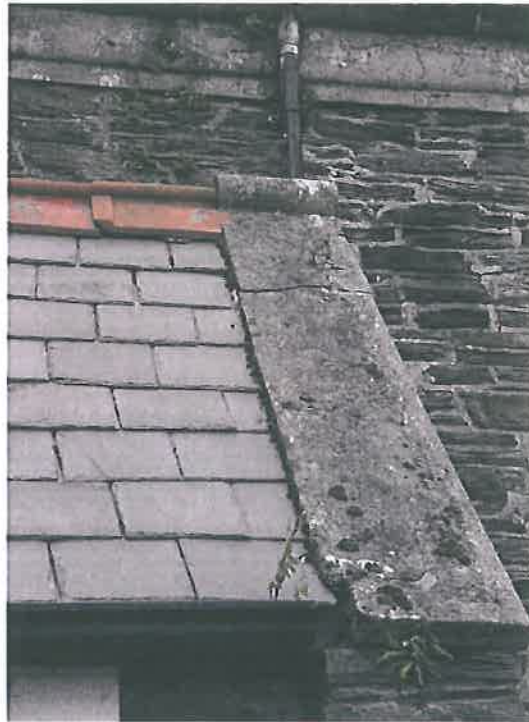
**Plate 7 – Porch (south), cracked verge capping and vegetation growth**

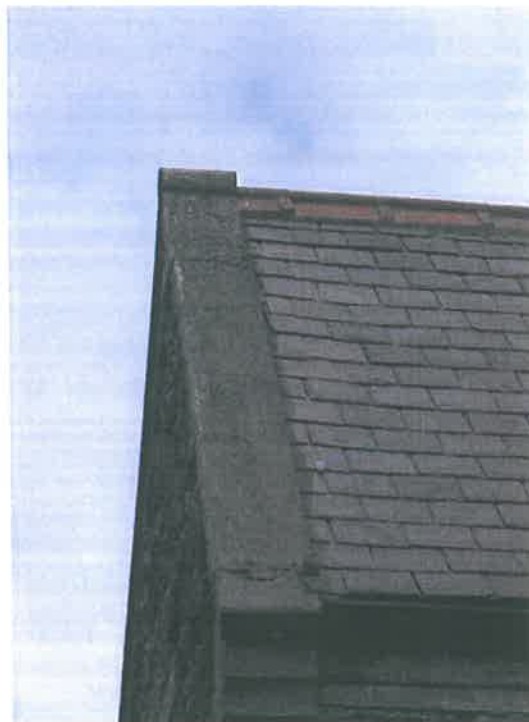
**Plate 8 – Residential unit roof verge capping, noting cracking to the capping**

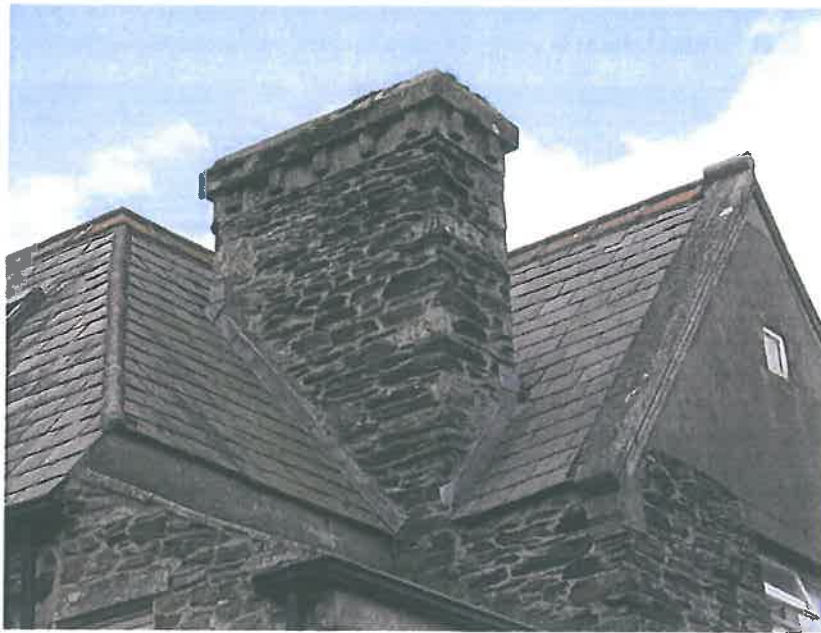
**Plate 9 – Chimney stack to retail unit noting general condition**

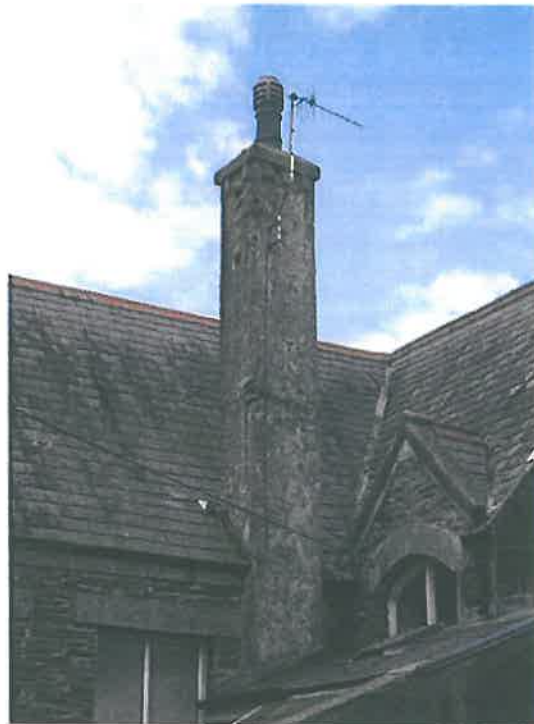
**Plate 10 – Chimney stack between Manxonia House and Overcliff, noting poor condition of the render and vegetation and lichen growth evident to the top of the stack and at the roof junction.**

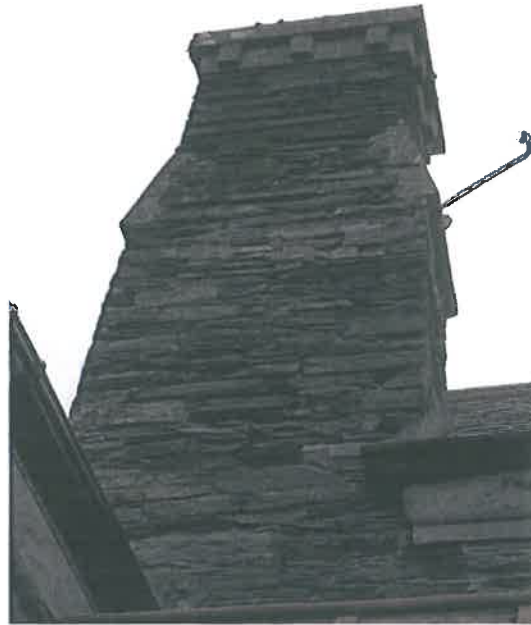
**Plate 11 – Chimney stack between Manxonia House and Beach House**

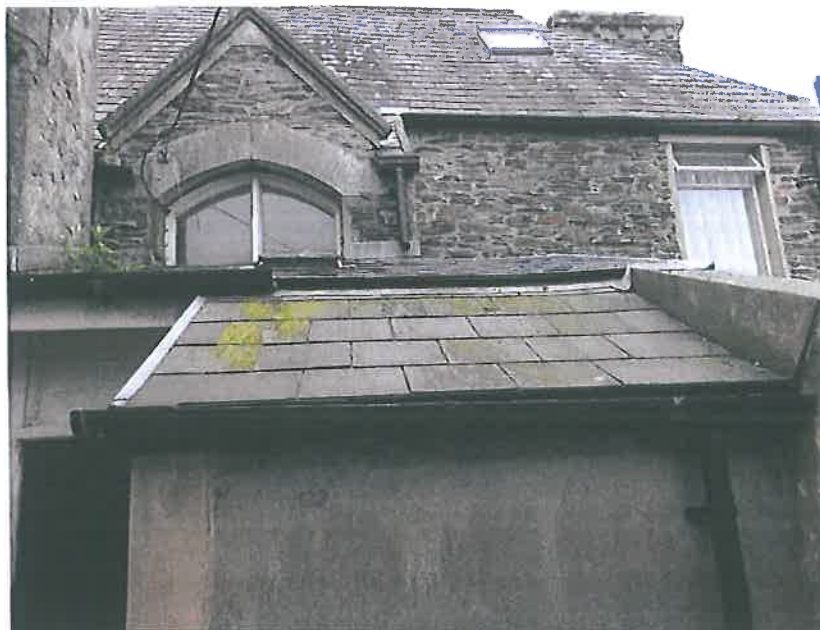
**Plate 12 – Mono pitch roof to the kitchen noting manmade slate and general condition**

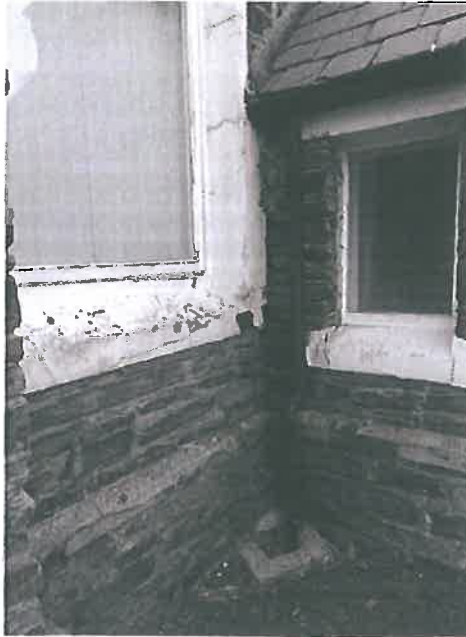
**Plate 13 – South west elevation external wall thickening at low level with concrete capping detail, noting general condition of the concrete capping to the wall at low level, cracked and crazed render to the window surround and poor condition of the render to the window head detail**

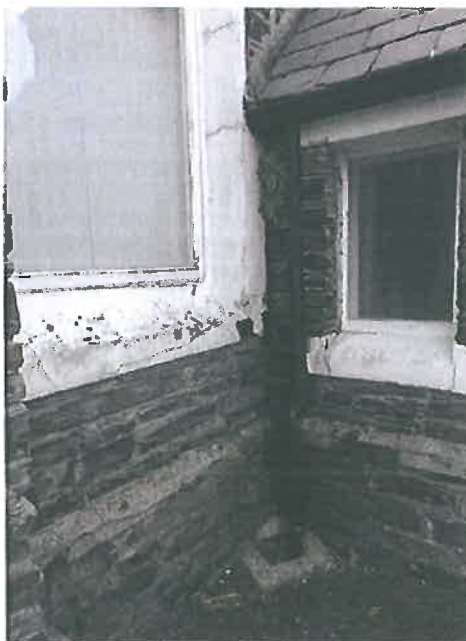
**Plate 14 – South west elevation, south porch noting vegetation and damp staining to the wall. Note general condition of the concrete capping to the wall at low level and the concrete window surrounds**

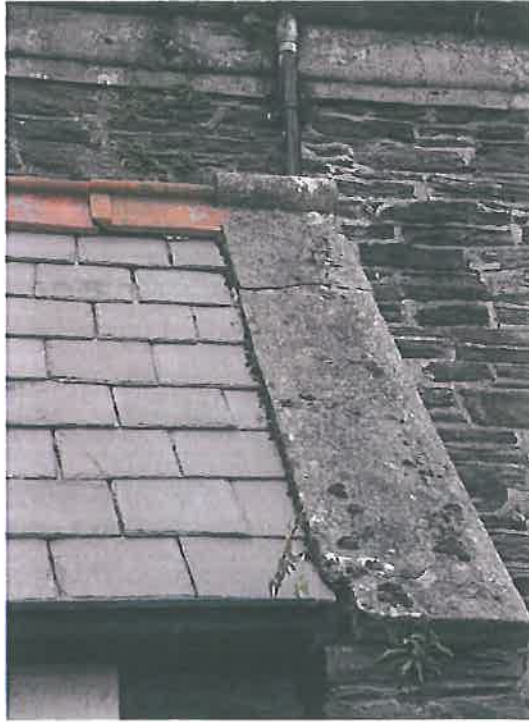
**Plate 15 – South west elevation, south porch, noting cracked concrete verge detail to the roof**

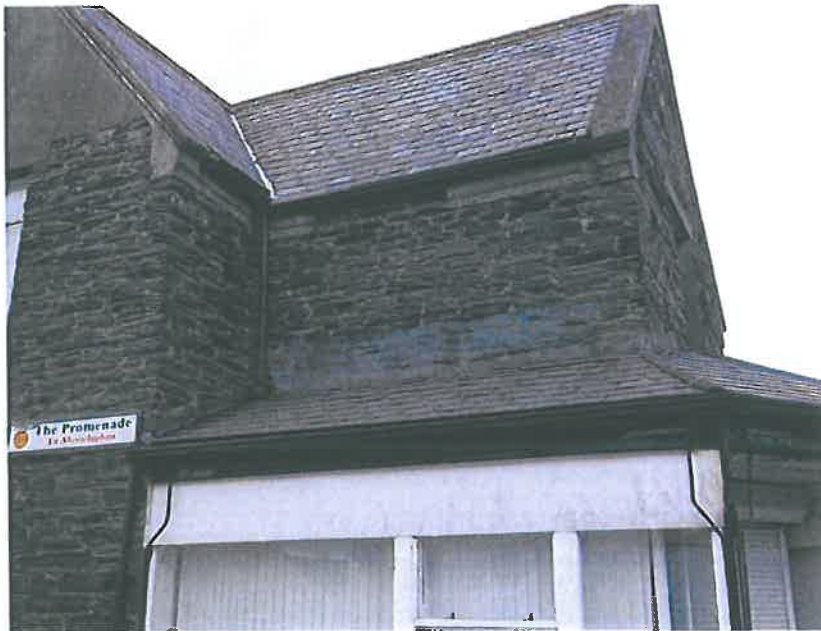
**Plate 16 – North west elevation, noting painted section of wall above the retail unit roof**

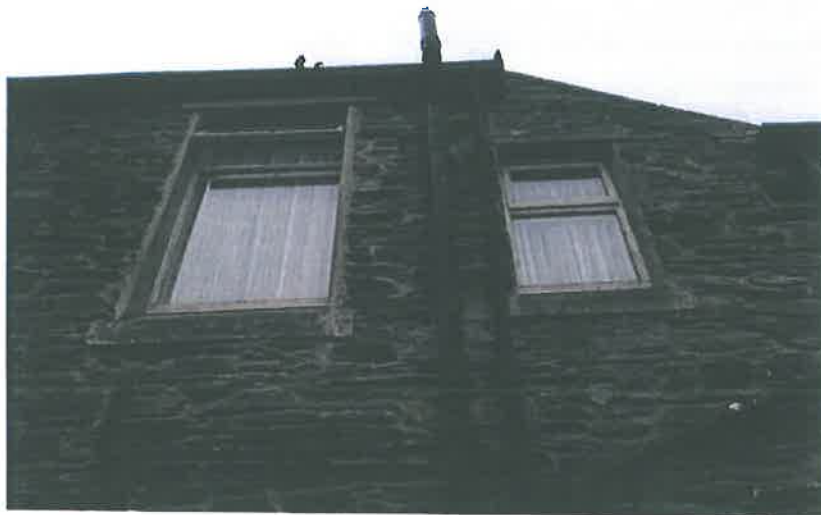
**Plate 18 – North east elevation noting vegetation to the gutter, cracked concrete to the window sills, patched/pointed stone and general condition of window**

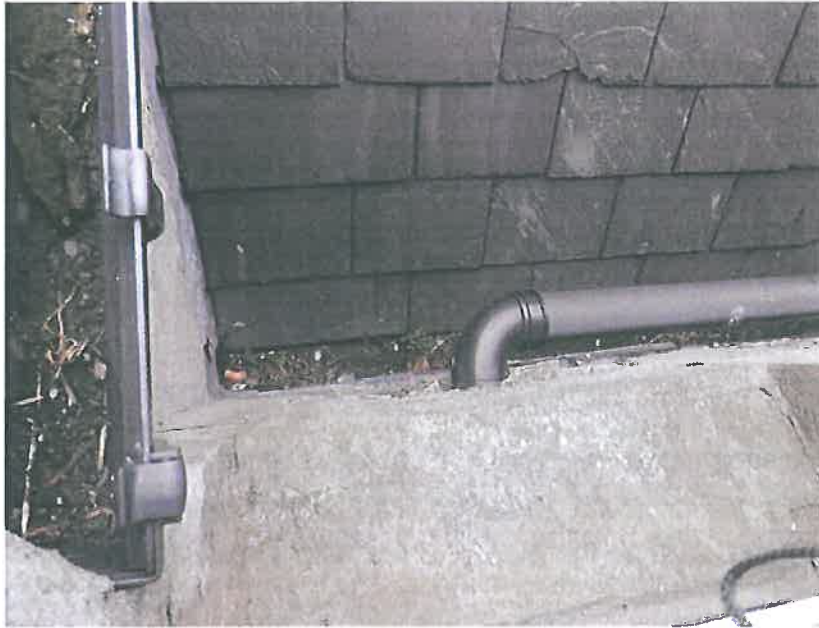
**Plate 19 – South west elevation, north porch roof valley noting debris and silt to the valley and gutter to the main roof. The pipe within the valley would appear to be the soil waste from the W.C. for the residential unit**

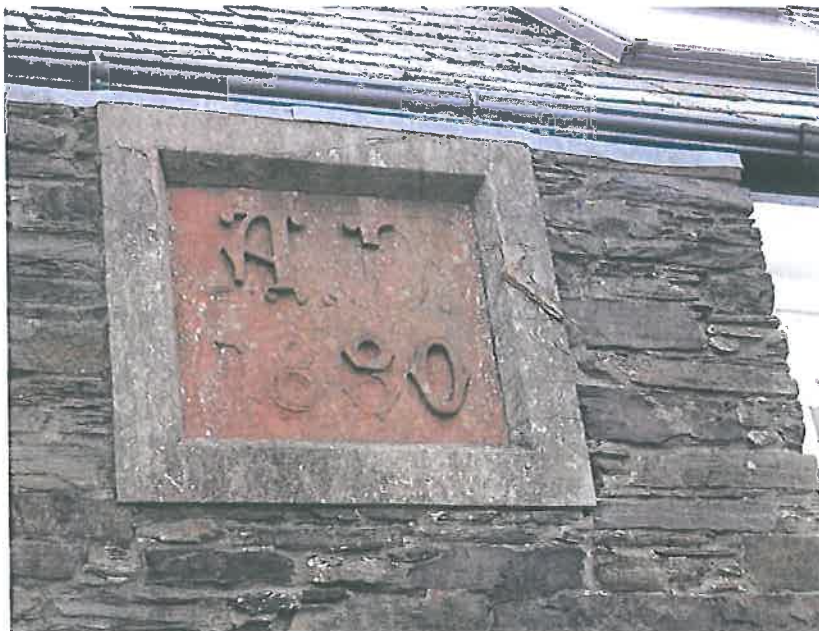
**Plate 20 – South west elevation, noting the lead capping to the external wall and deterioration of the sandstone plaque**

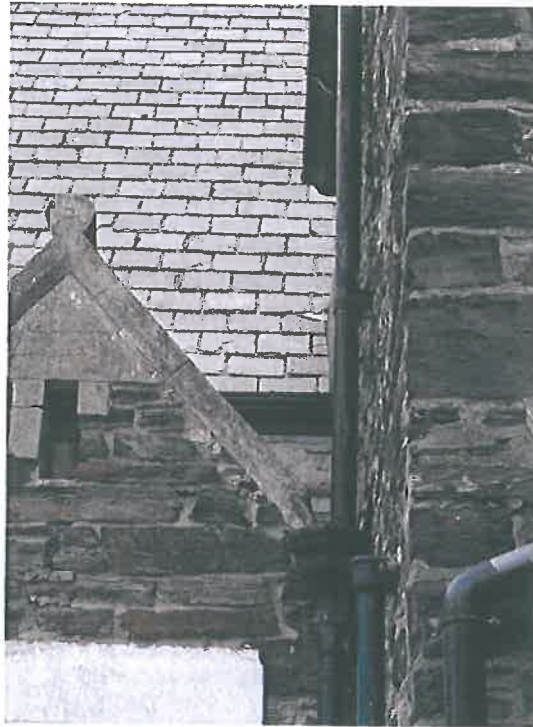
**Plate 21 – South west elevation, south porch apex to gable noting crazed and cracked concrete areas, missing facing to apex porthole and areas of poor pointing**

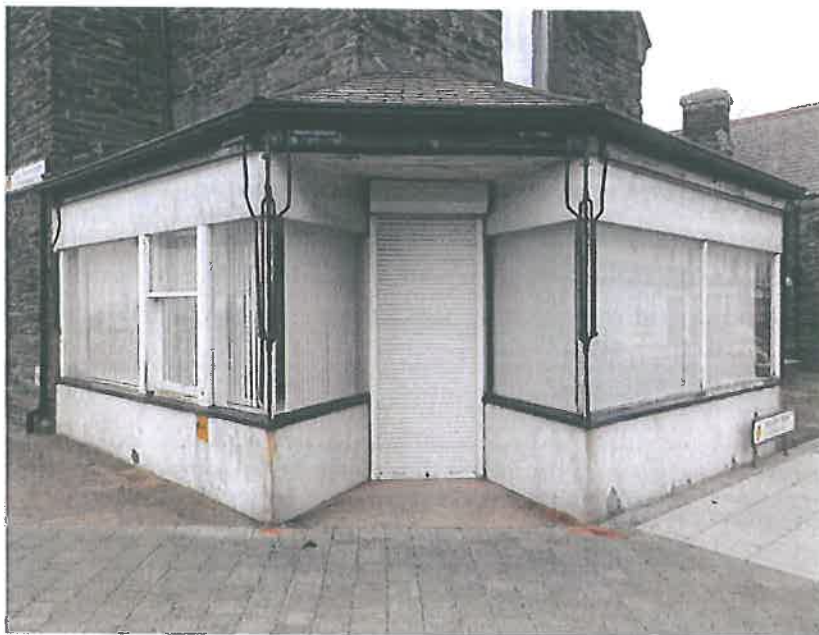
**Plate 22 – Corner of south west and north west elevation. Retail unit facade noting shallow roof pitch, general condition and corroded condition of metalwork for the shopfront awning**

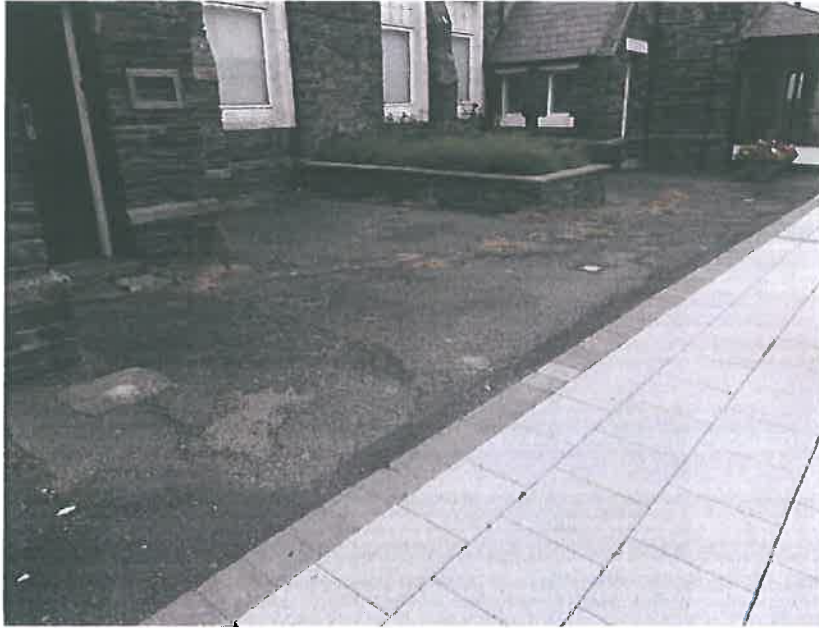
**Plate 23 – South west elevation paved area, noting poor condition of the tarmac surface**

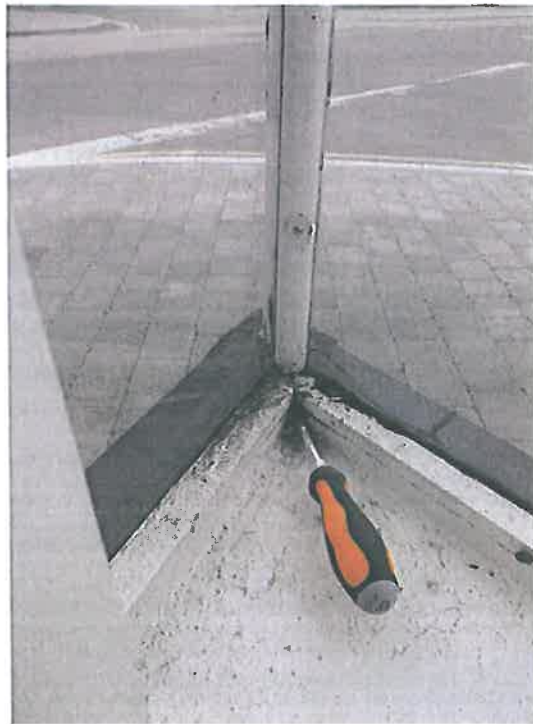
**Plate 24 – South west elevation, rot to window and poor decorative condition**

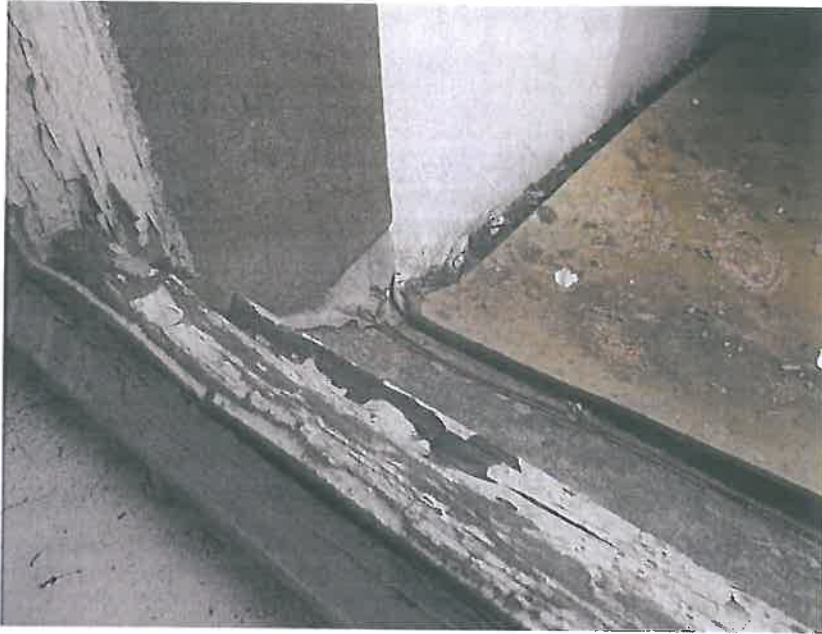
**Plate 25 – North east elevation, noting poor condition of timber to window externally**

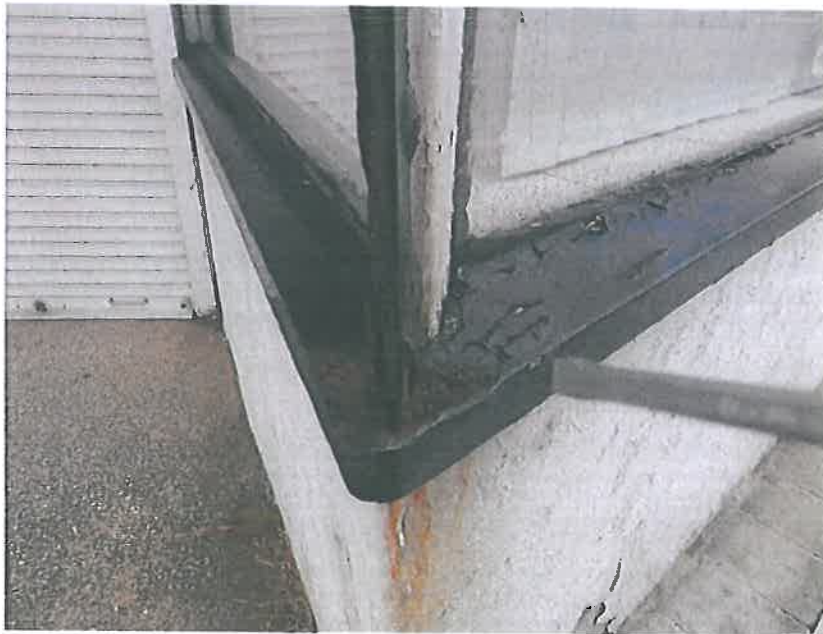
**Plate 26 – North west elevation retail unit, noting poor condition of the timber window sill section**

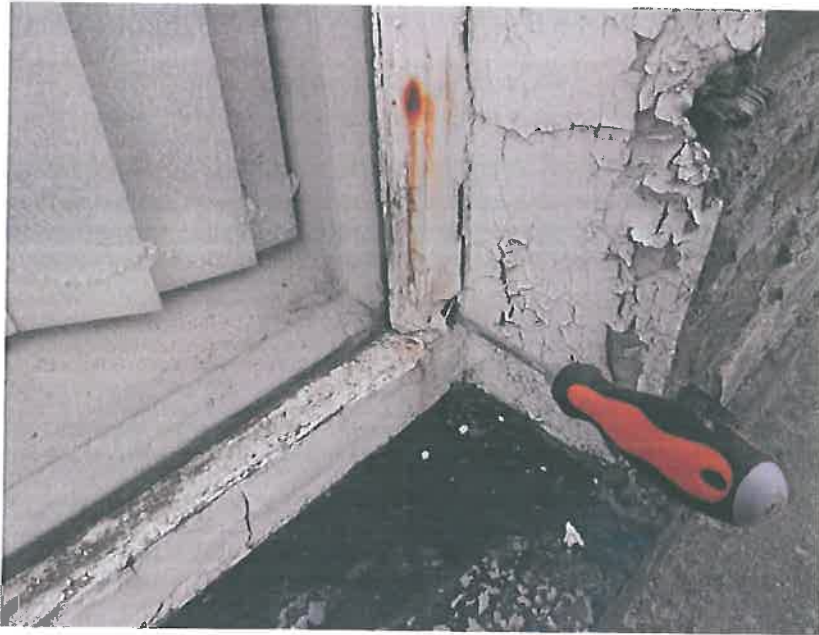
**Plate 27 – North west elevation, retail unit, noting poor condition of window to the W.C.**

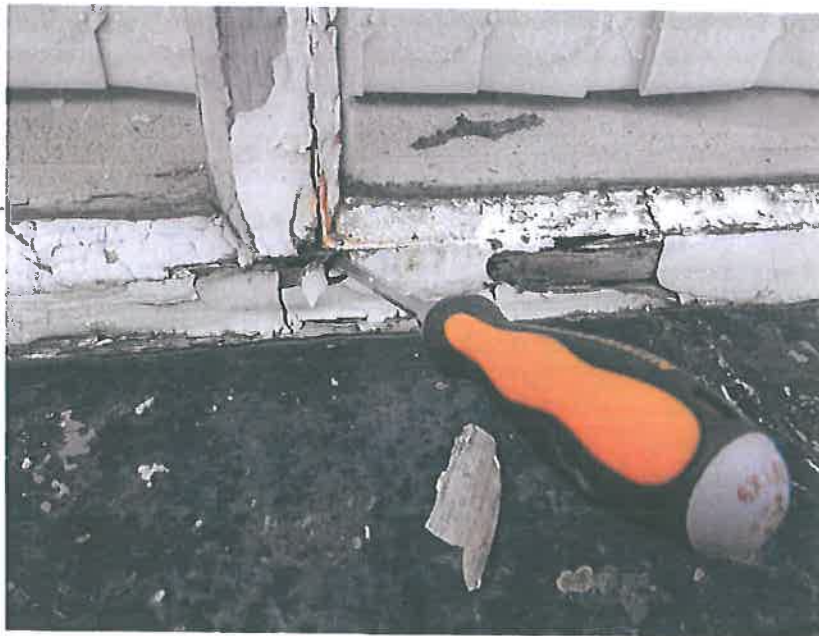
**Plate 28 – Window, noting poor condition generally**

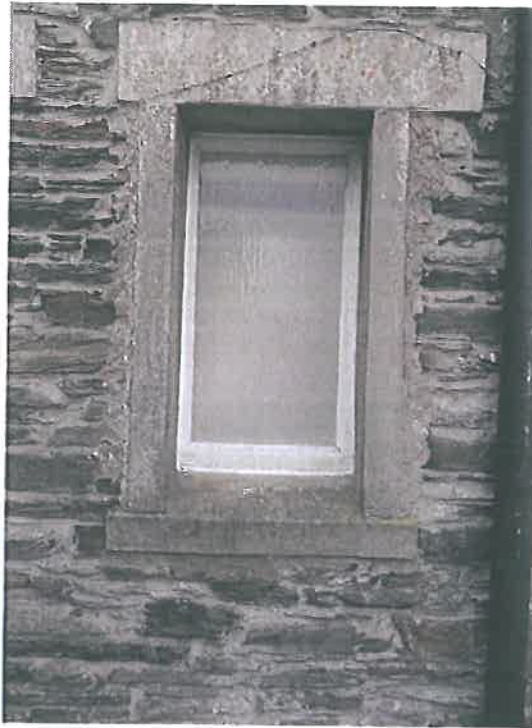
**Plate 29 – Window to the retail unit noting poorly applied mortar around reveal detailing**

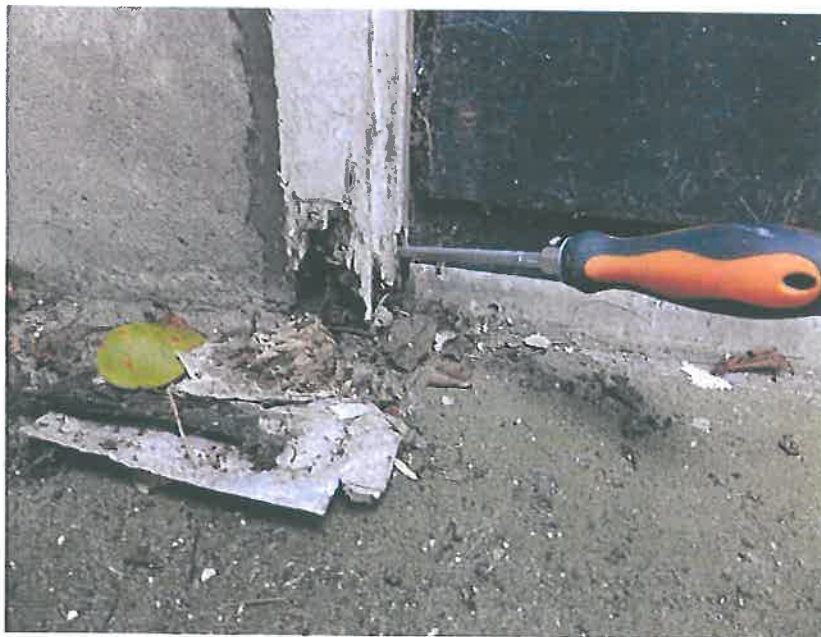
**Plate 30 – North east elevation, kitchen door, noting rot to the door frame and general condition**

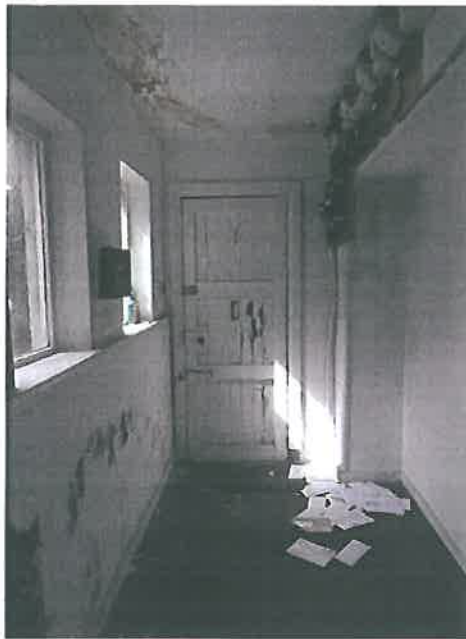
**Plate 31 – North porch interior noting general condition and multiple meters and electrical equipment**

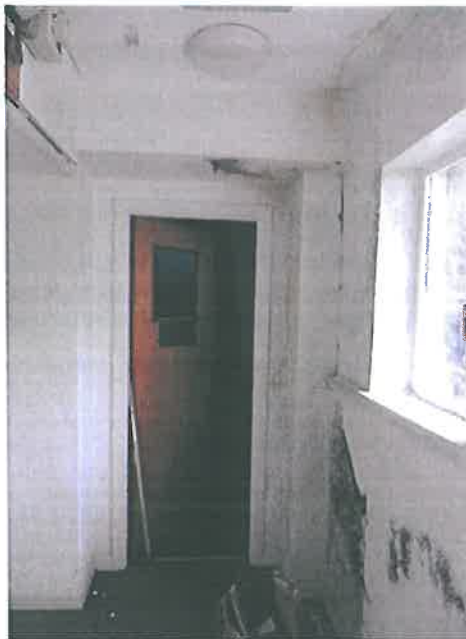
**Plate 32 – North porch interior looking towards the inner hall noting general condition**

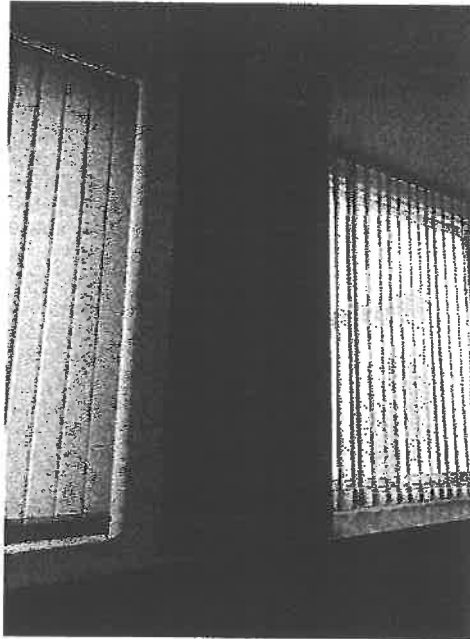
**Plate 33 – Ground floor offices, noting damp staining to the walls. Note wall below window is overboarded**

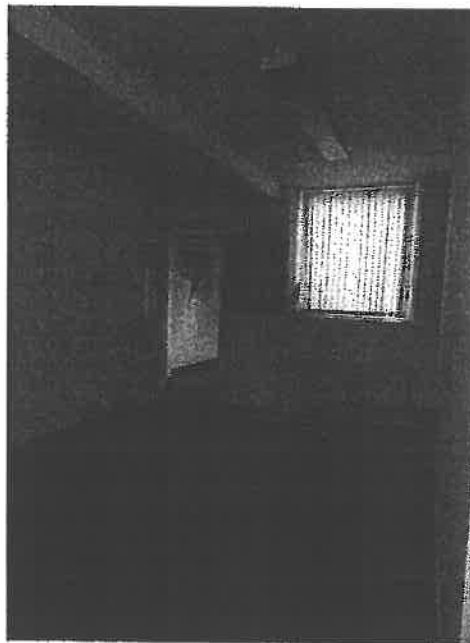
**Plate 34 – Ground floor offices looking towards the south porch, noting general condition**

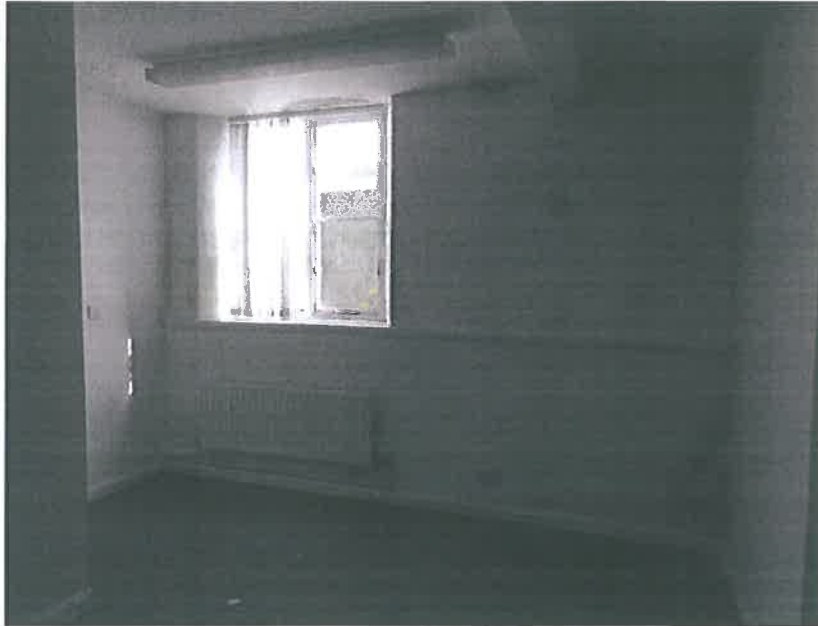
**Plate 35 – Ground floor office looking towards the adjoining property**

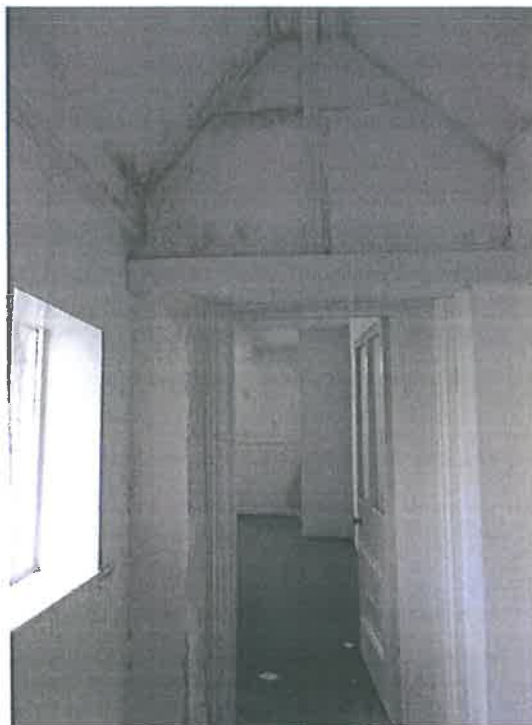
**Plate 36 – South porch junction with main external wall, noting general condition**

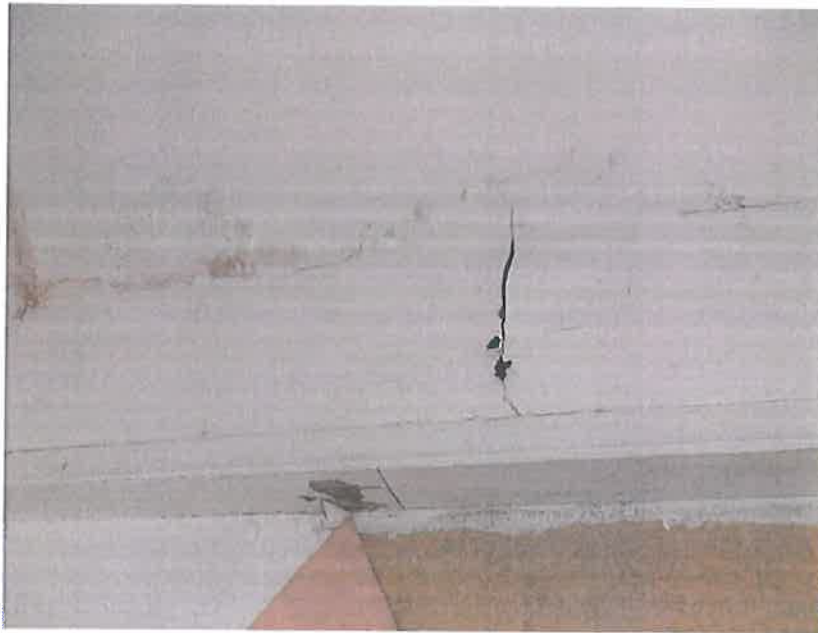
**Plate 37 – South porch noting vegetation/mould growth evident to the valley area**

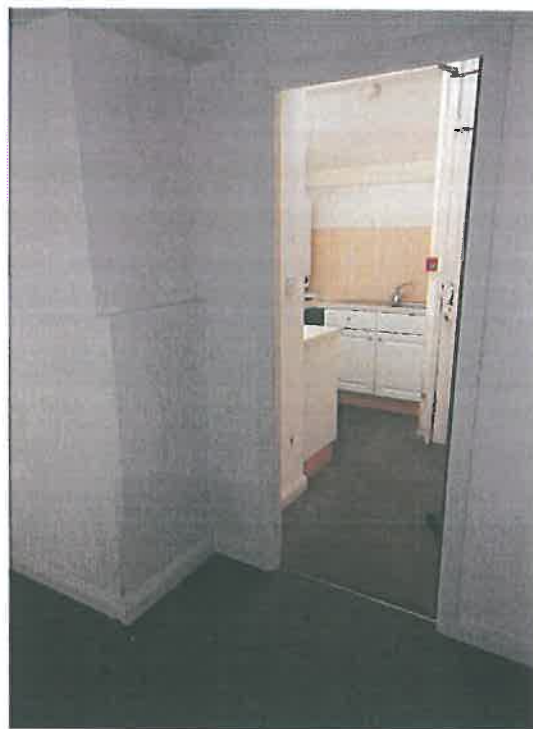
**Plate 38 – Office corridor area looking towards the kitchen noting general condition**

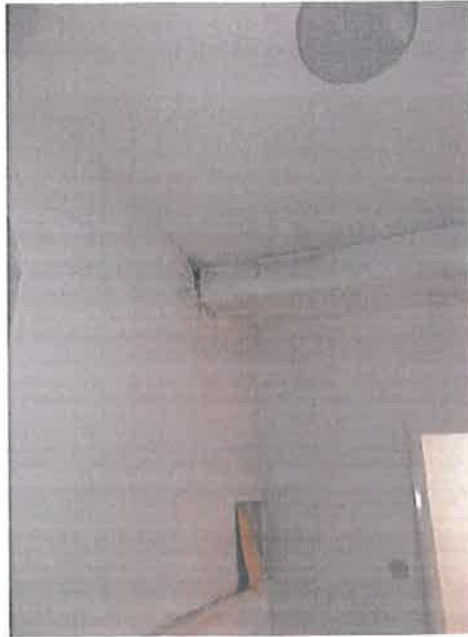
**Plate 39 – Office corridor area noting damp ingress to downstand beam and external wall**

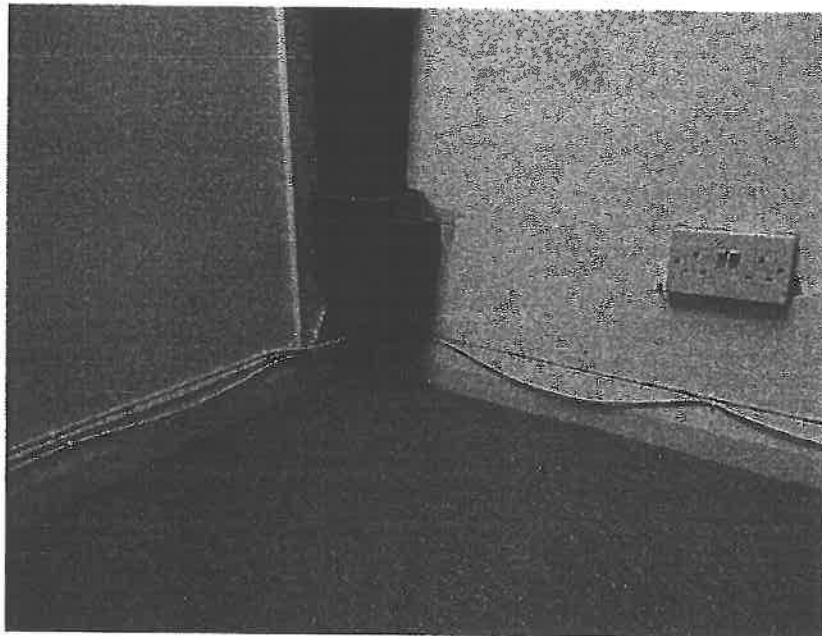
**Plate 50 – First floor office (south), noting missing section of truss padstone**

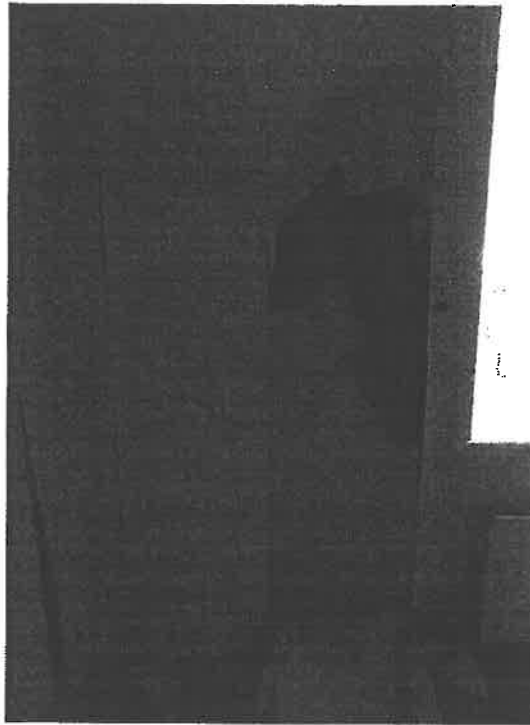
**Plate 51 – Residential unit, first floor noting general condition**

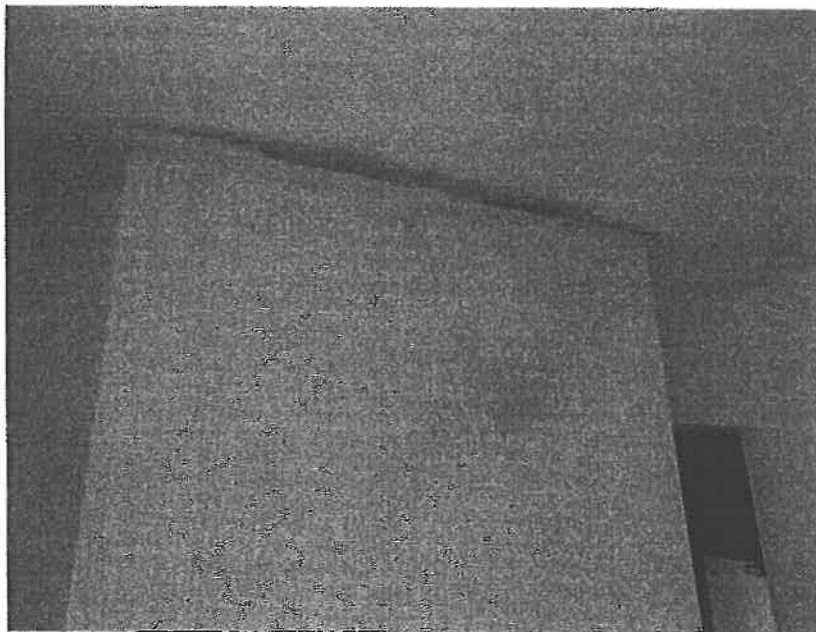
**Plate 52 – Residential unit, first floor noting damp ingress to chimney breast ceiling**

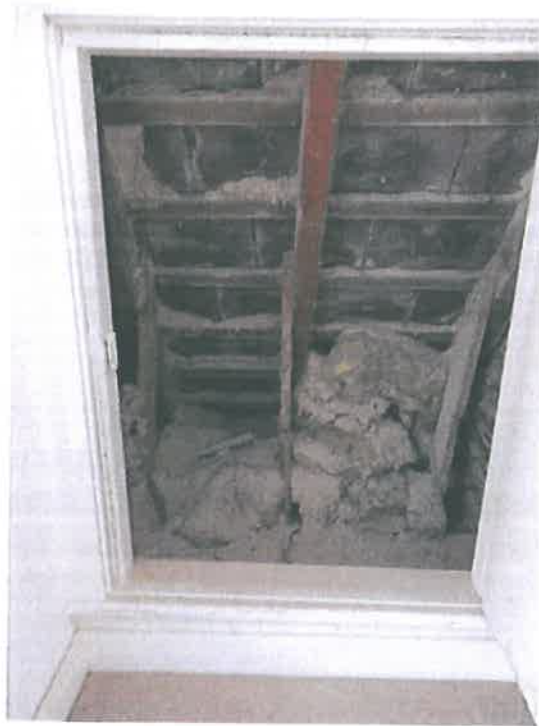
**Plate 53 – Residential unit, second floor, eaves void cupboard noting lack of torching and general condition**

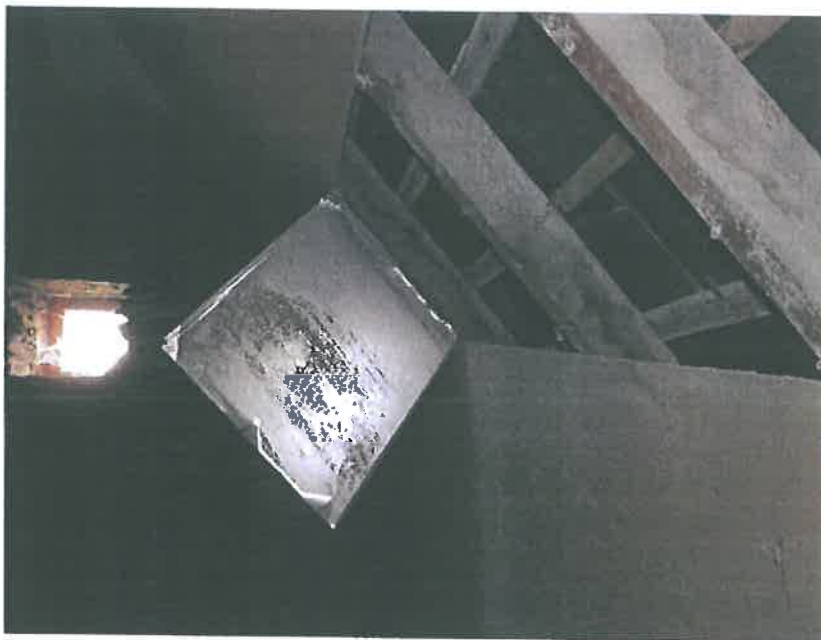
**Plate 54 – Residential unit, north roof void noting rafters boarded with foil backed plasterboard and damp staining to rafters**

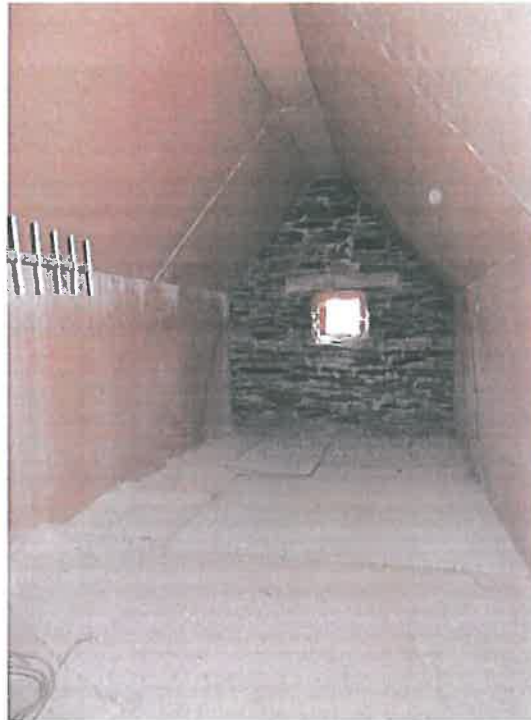
**Plate 55 – Residential unit, west roof void, noting damp staining to plasterboard adjacent to the external wall and to the junction of the vertical board and sloping roof. Note build up of pointing to the floor adjacent to the wall**

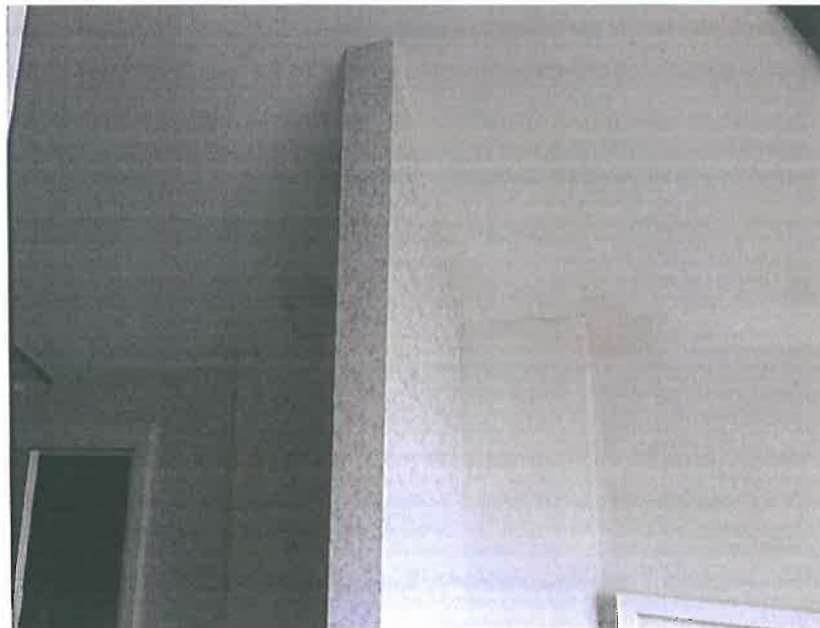
**Plate 56 – Residential unit bathroom noting damp ingress to the wall and soffit**

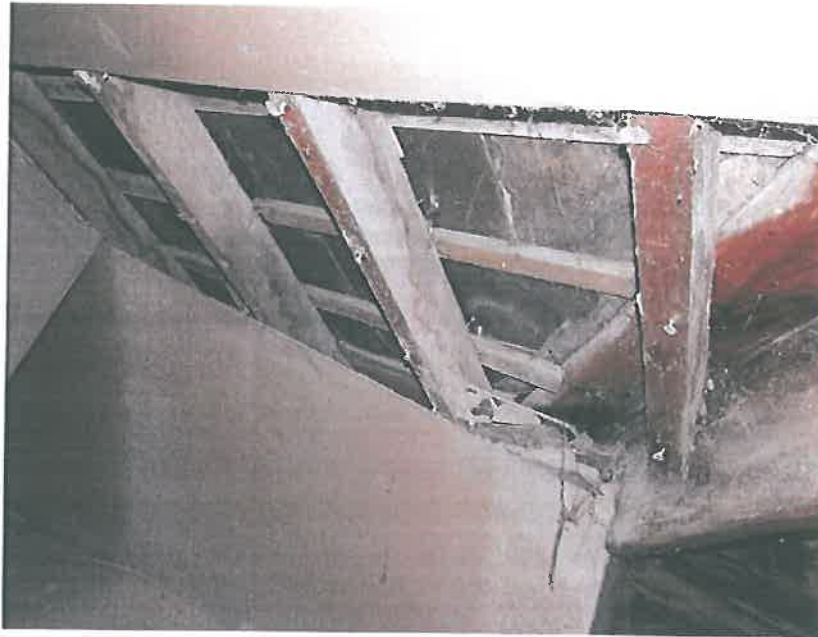
**Plate 57 – Residential unit, north roof void, noting damp staining to the valley lay board and rafters**
