Pre Refurbishment Asbestos Survey Report

Client: Port St Mary Commissioner's

Location: Manxonia House, Port St Mary, Isle of Man

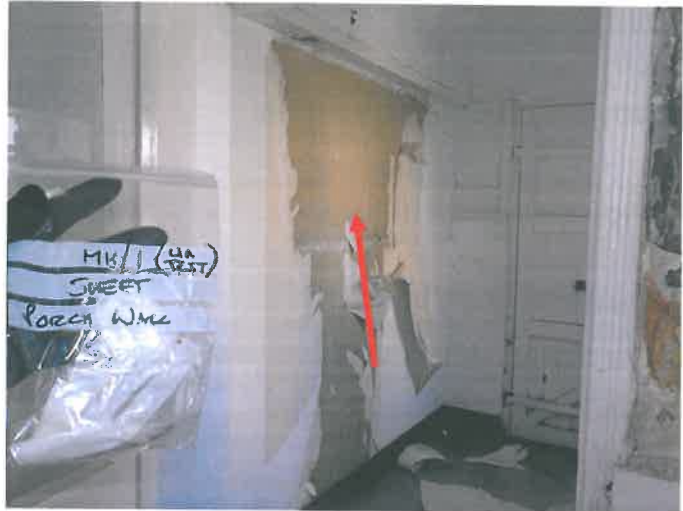
Sample No: MH1

Location: Entrance porch wall

Product type: Sheet

Asbestos Detected

Asbestos cement – Chrysotile

A water absorption test has been carried out and the result is included in this document

This material can be removed as Non Licensed Work by a trained and competent contractor in accordance with HSG210 Asbestos Essentials

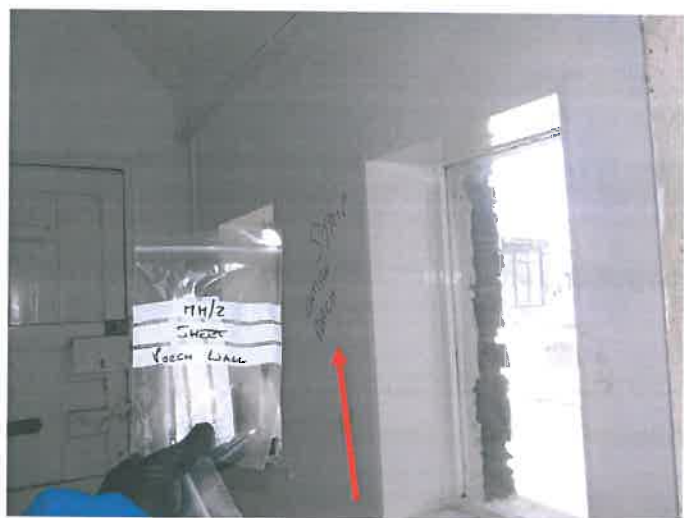
Sample No: MH2

Location: Entrance porch wall

Product type: Sheet

No Asbestos Detected

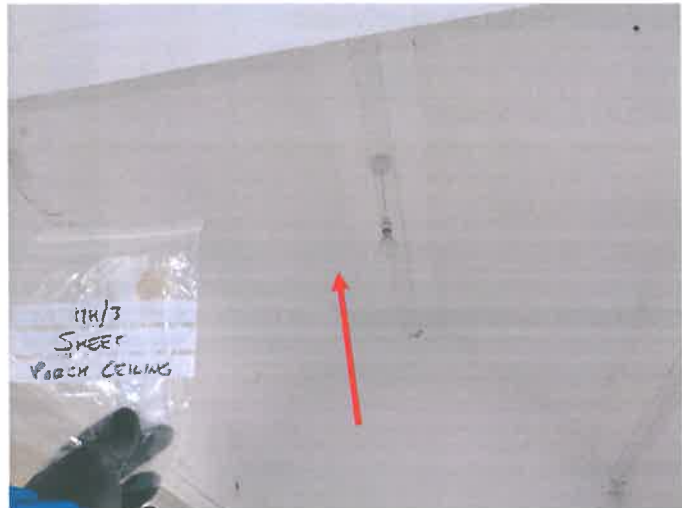
Sample No: MH3

Location: Entrance porch ceiling

Product type: Sheet

No Asbestos Detected

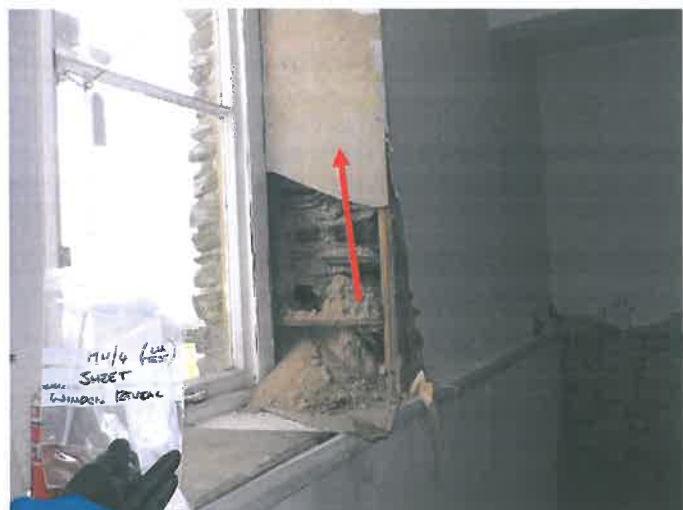
Sample No: MH4

Location: Window reveal

Product type: Sheet

Asbestos Detected

Asbestos cement – Chrysotile

A water absorption test has been carried out and the result is included in this document

This material can be removed as Non Licensed Work by a trained and competent contractor in accordance with HSG210 Asbestos Essentials

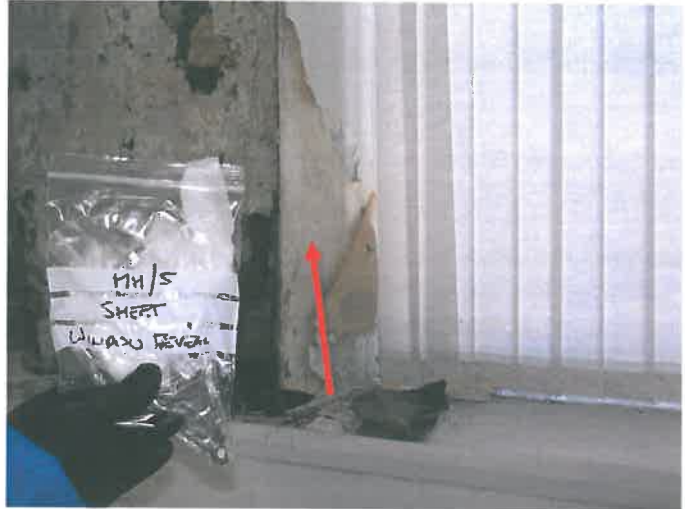
Sample No: MH5

Location: Window reveal

Product type: Sheet

Asbestos Detected

Asbestos cement – Chrysotile

This material can be removed as Non Licensed Work by a trained and competent contractor in accordance with HSG210 Asbestos Essentials

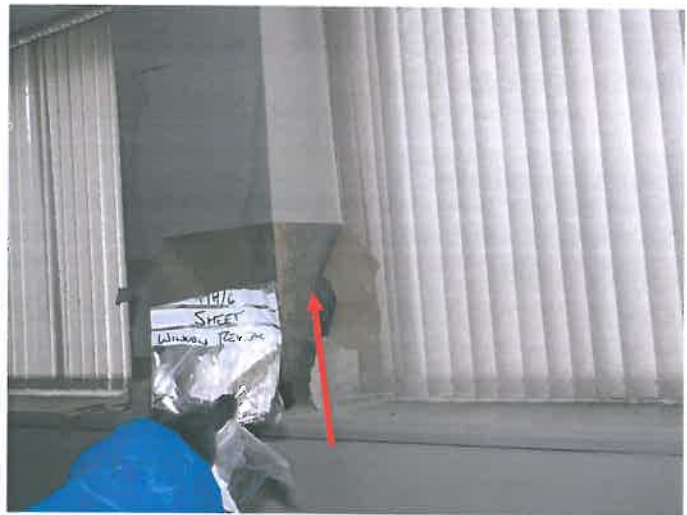
Sample No: MH6

Location: Window reveal

Product type: Sheet

Asbestos Detected

Asbestos cement – Chrysotile

This material can be removed as Non Licensed Work by a trained and competent contractor in accordance with HSG210 Asbestos Essentials

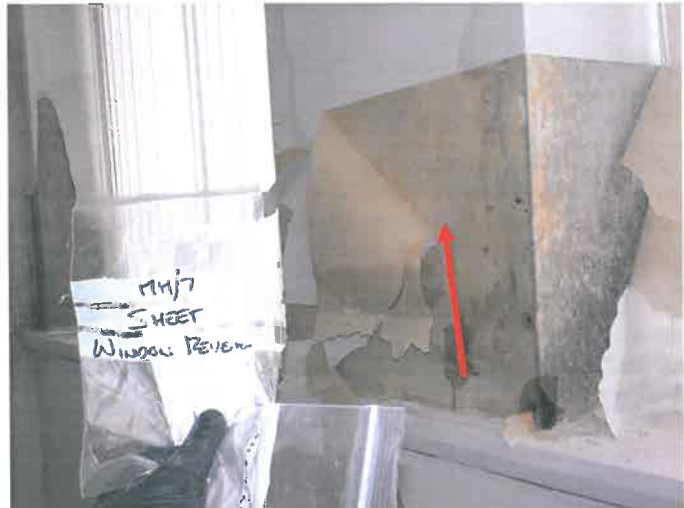
Sample No: MH7

Location: Wall between windows

Product type: Sheet

No Asbestos Detected

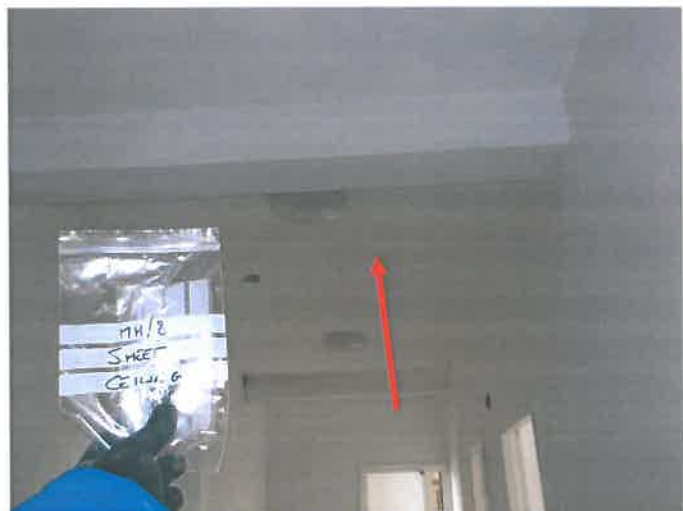
Sample No: MH8

Location: Corridor ceiling

Product type: Sheet

No Asbestos Detected

Material common throughout the building

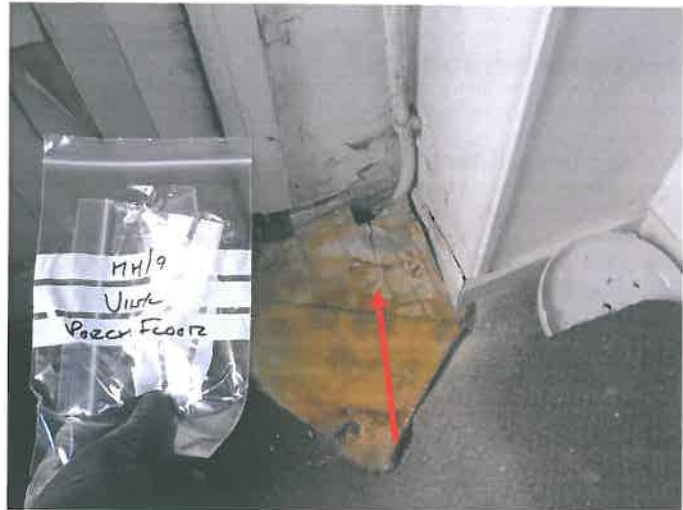
Sample No: MH9

Location: Entrance porch floor

Product type: Vinyl covering

No Asbestos Detected

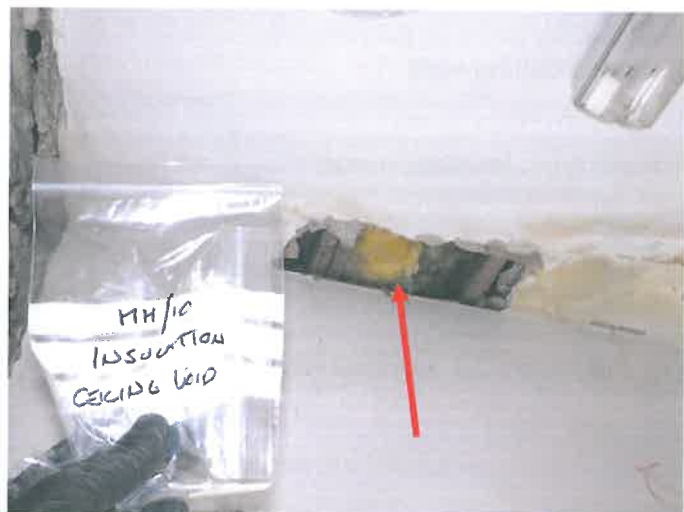
Sample No: MH10

Location: Ceiling void

Product type: Insulation mat

No Asbestos Detected

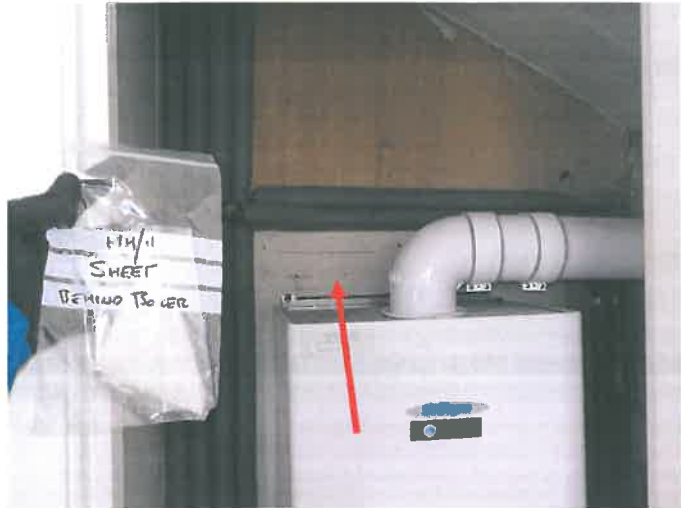
Sample No: MH11

Location: Boiler cupboard

Product type: Sheet behind boiler

No Asbestos Detected

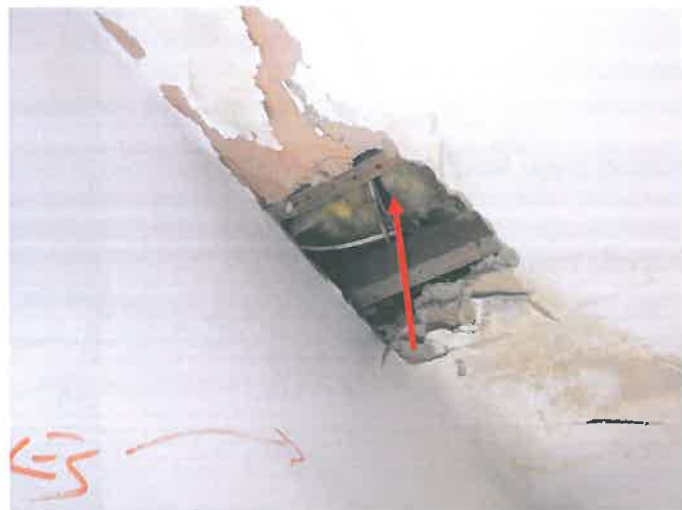
Sample No: MH12

Location: Ceiling void

Product type: Insulation mat

No Asbestos Detected

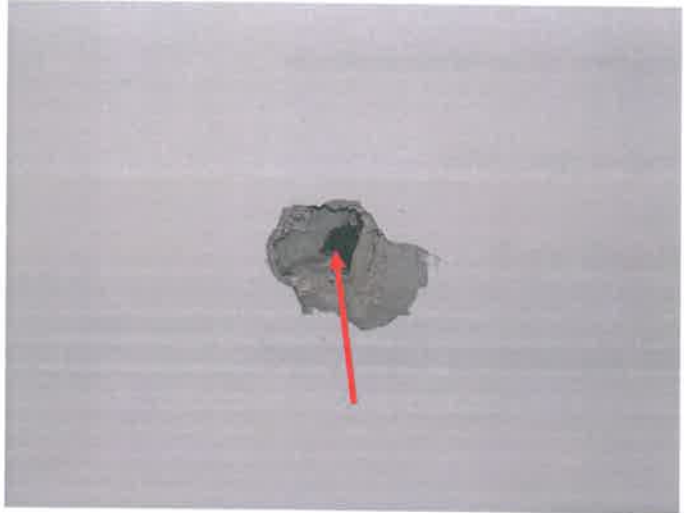
Sample No: MH13

Location: Ceilings

Product type: Bitumen paper

No Asbestos Detected

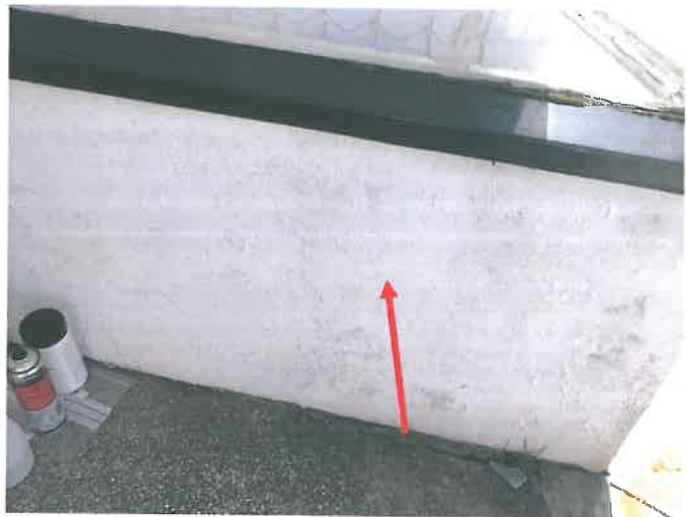
Sample No: MH15

Location: Shop window panels

Product type: Artex

No Asbestos Detected

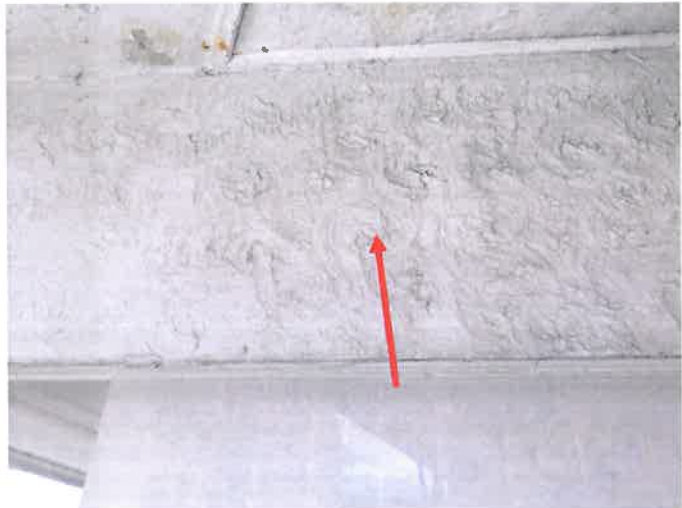
Sample No: MH14

Location: Shop window panels

Product type: Artex

No Asbestos Detected

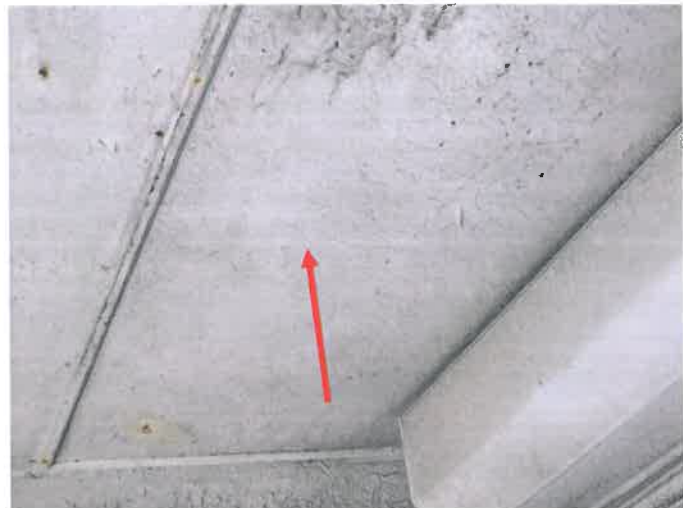
Sample No: MH16

Location: Shop entrance porch soffit

Product type: Sheet

No Asbestos Detected

The soffit is in two sections – this sample was taken from the rear half

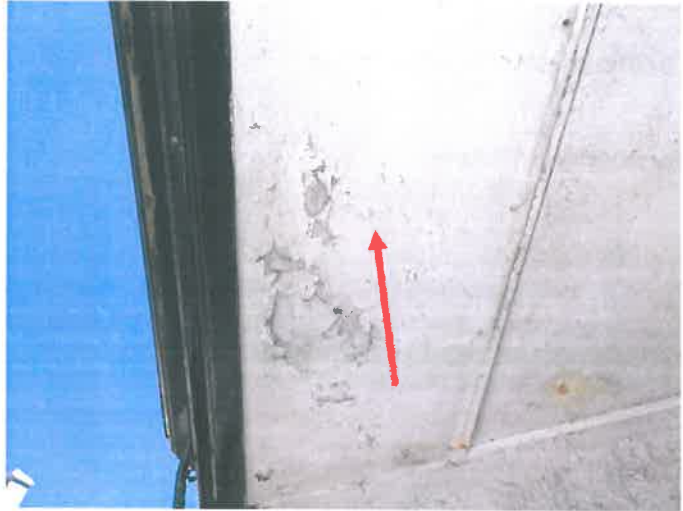
Sample No: MH17

Location: Shop entrance porch soffit

Product type: Sheet

Asbestos Detected

Asbestos cement – Chrysotile

Front section of porch soffit

This material can be removed as Non Licensed Work by a trained and competent contractor in accordance with HSG210 Asbestos Essentials

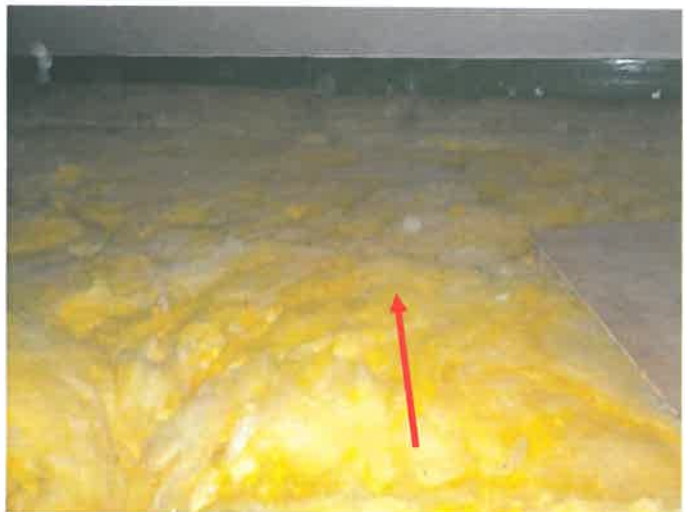
Sample No: MH18

Location: Roof space

Product type: Insulation mat

No Asbestos Detected

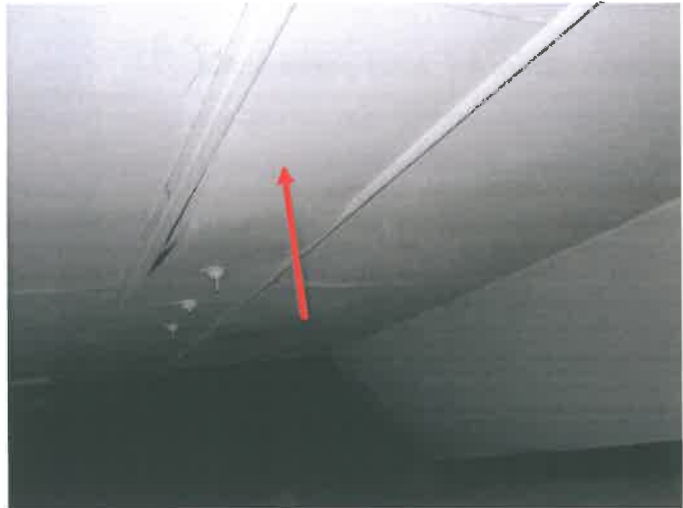
Sample No: MH19

Location: Roof space ceiling

Product type: Sheet

No Asbestos Detected

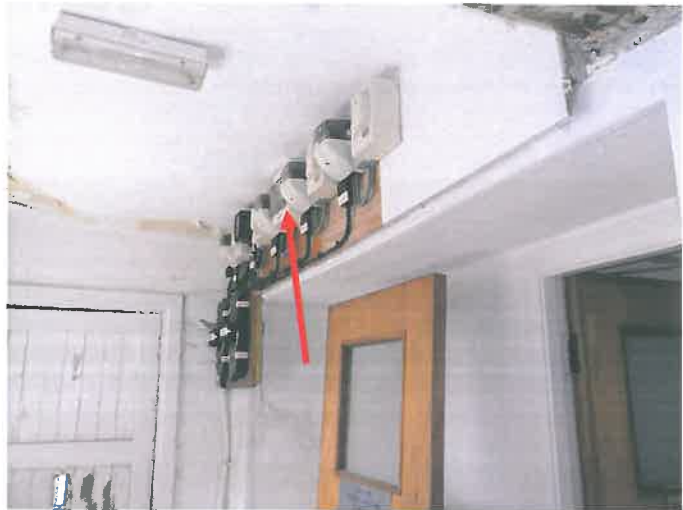
Presumed materials

Location: Entrance porch

Product type: Switchgear

Asbestos Detected

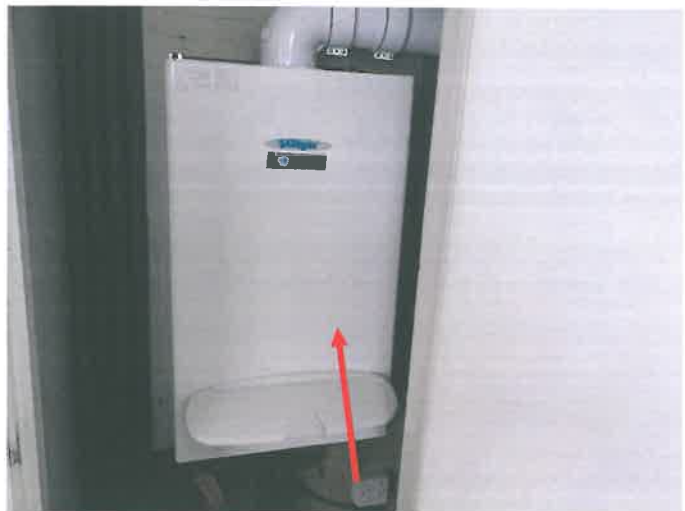
Presumed materials

Location: Boiler cupboard

Product type: Boiler internal parts

Asbestos Detected
